# भारत का राजपत्र The Gazette of India

“17 अक्टूबर, 2003 को मैसर्स सिंगरेनी कोलियरी कम्पनी लिमिटेड की कोयला खानों में हुई बड़ी दुर्घटना, जिसमें 10 लोगों की मृत्यु हुई, के संबंध में जांच अदालत की रिपोर्ट”

मैसर्स सिंगरेनी कोलियरी कम्पनी लिमिटेड के गोदावरीखनी सं. 8ए इन्क्लाइन खान में दिनांक 17 अक्टूबर, 2003 को घटित 10 व्यक्तियों की प्राणघातक दुर्घटना पर

जांच न्यायालय का प्रतिवेदन

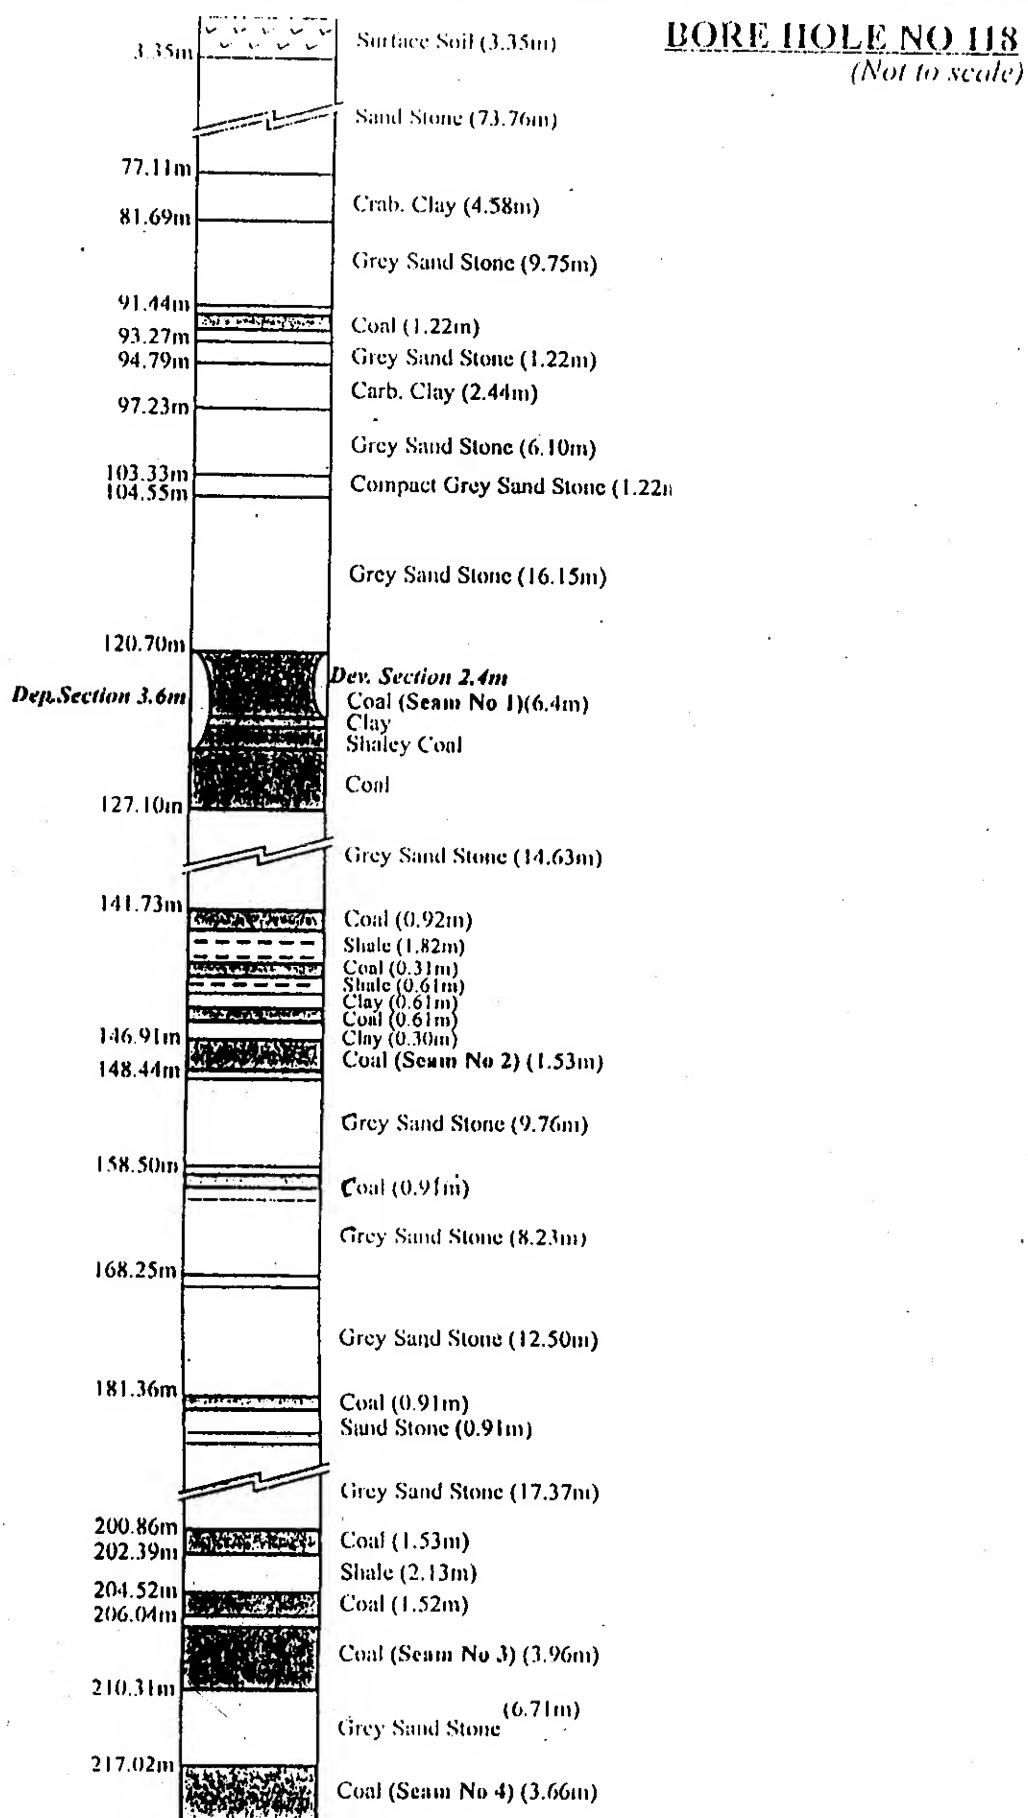
Fig 1: Section along Bore Hole No 118 showing different seams at GDK8A Incline, SCCL.

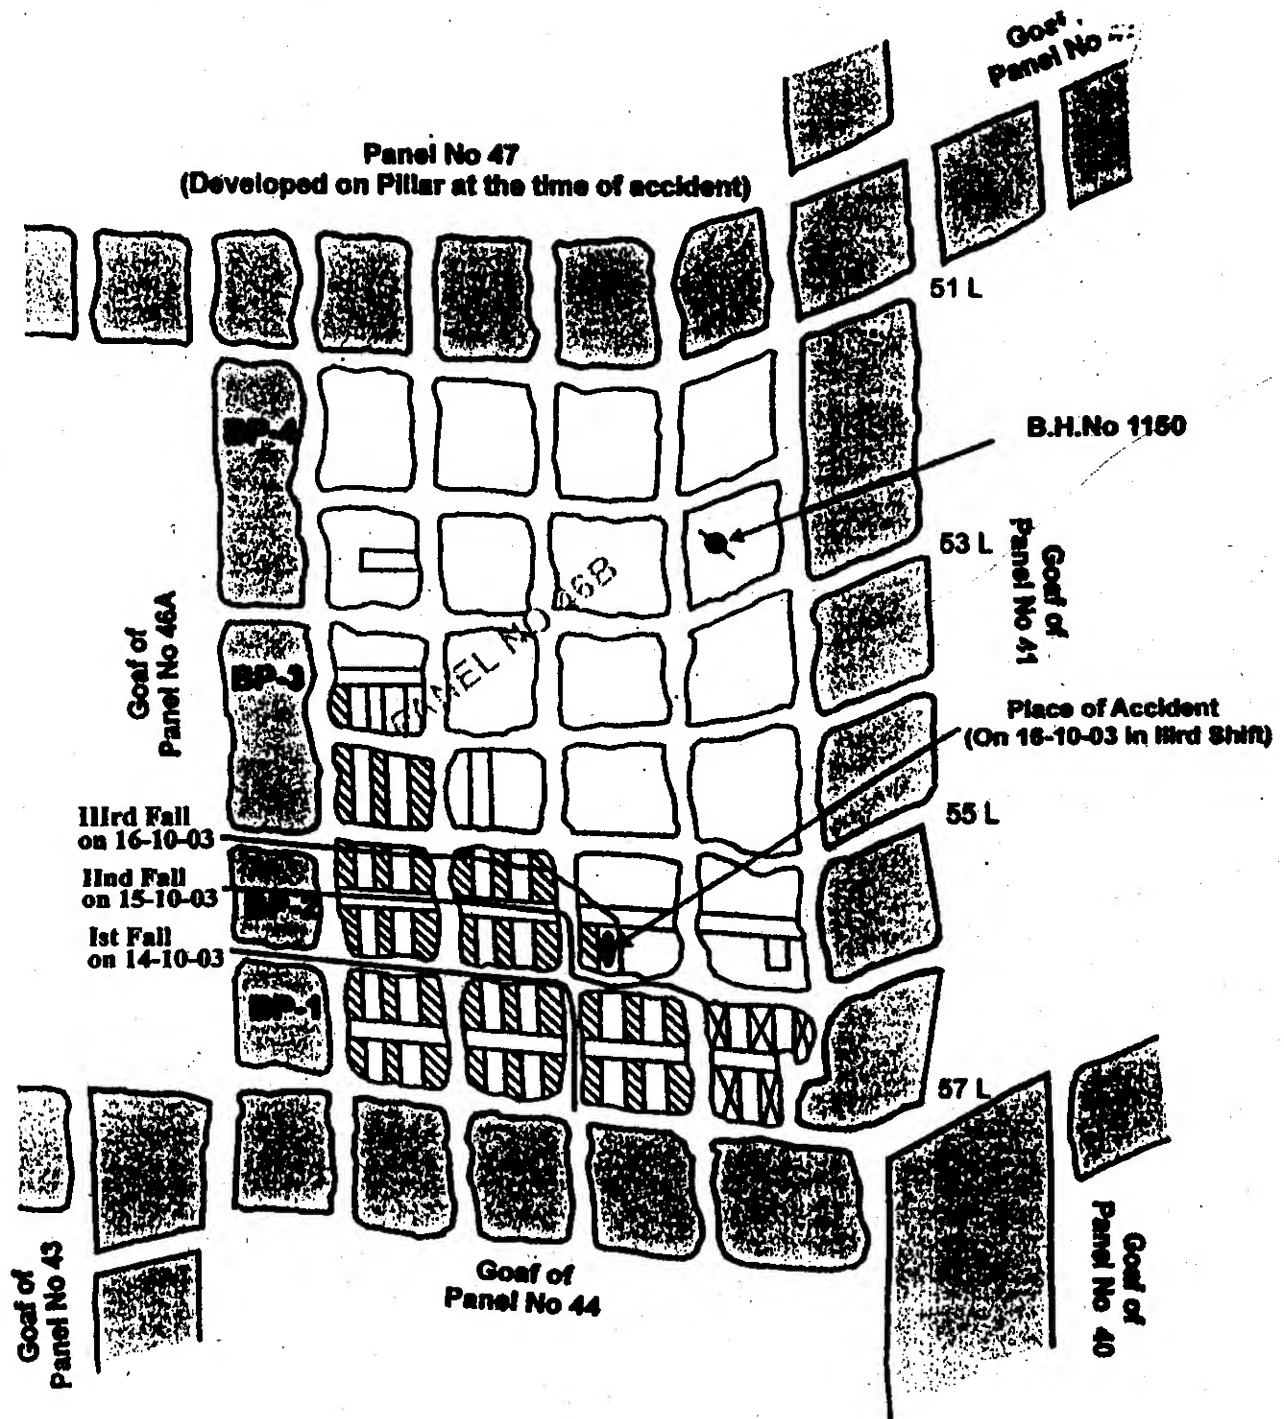
Fig 2: Part plan of the panel no 46B showing line of different falls, Bore Hole position from where rock sample were tested in CMRI laboratory for modelling.

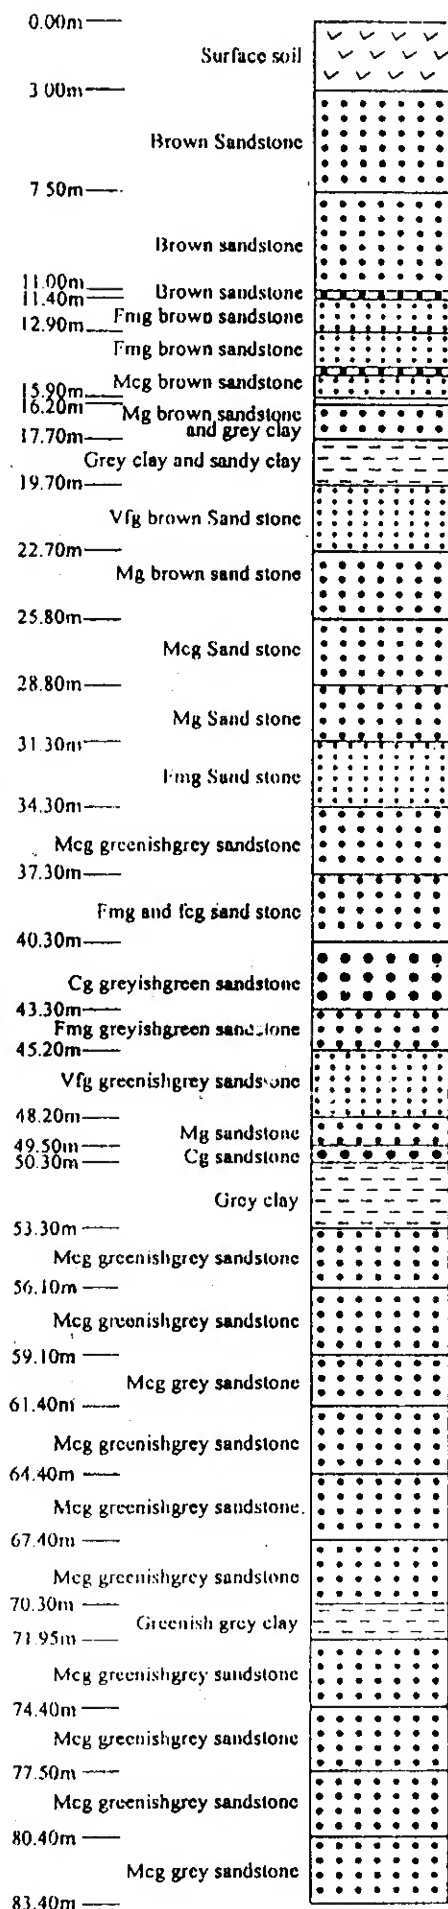
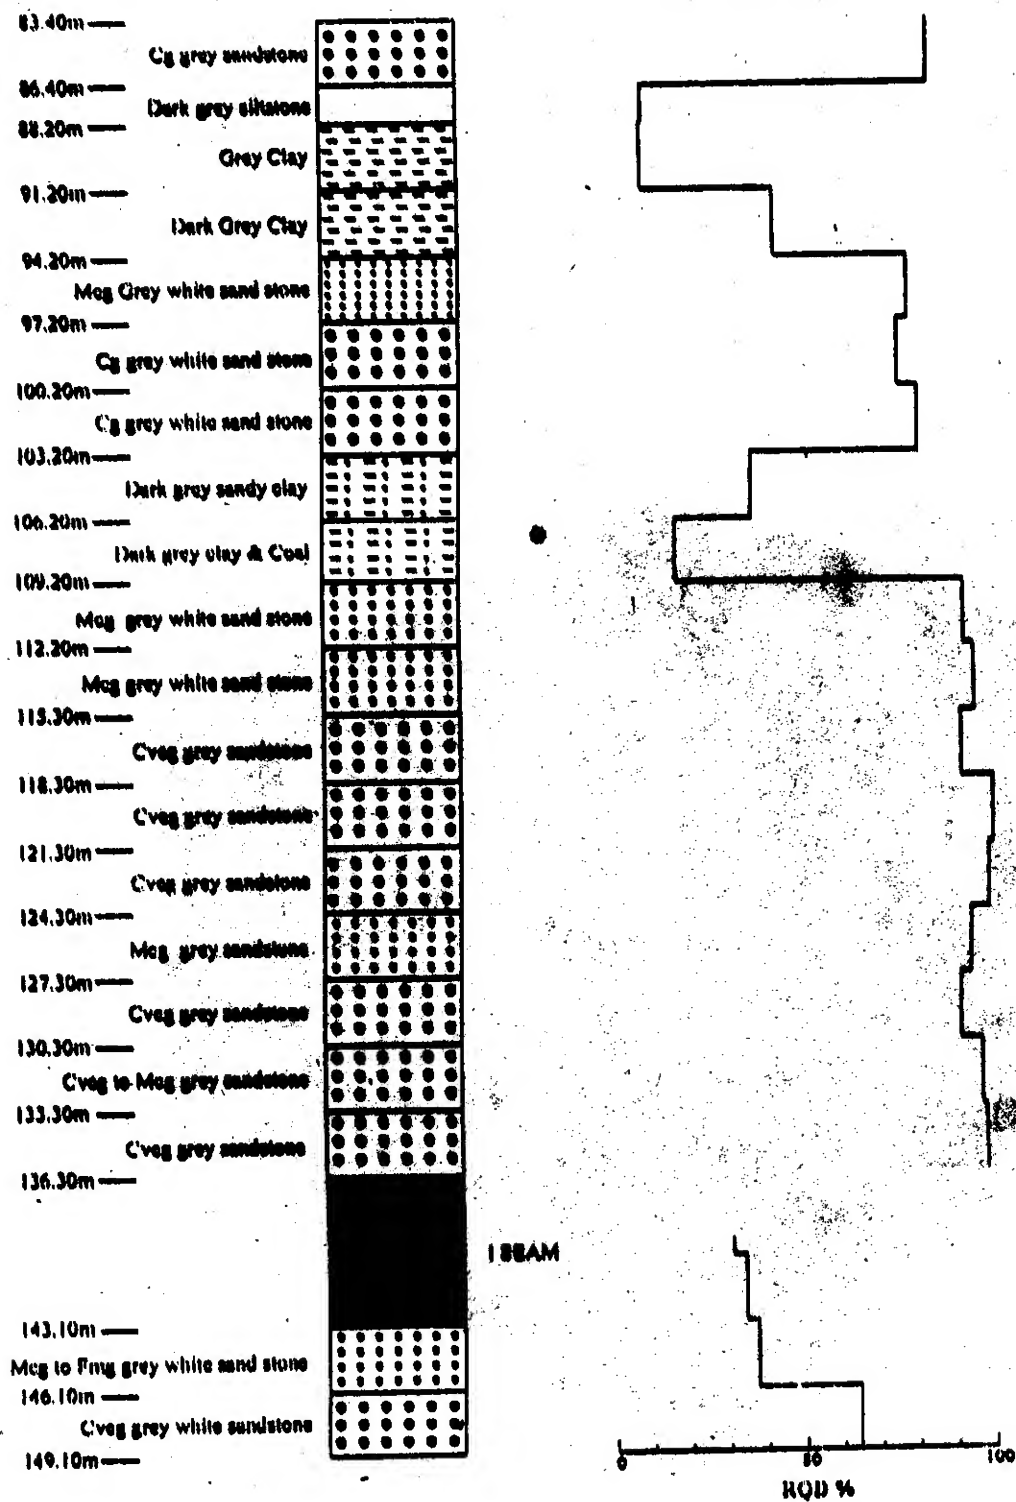
**BORE HOLE NO ; 1150**  
**LOCATION : GDK-8A INCLINE**  
*(Not to scale)*

Fig 3: Section along Bore Hole No 1150, located at panel no 46B, where rock samples were tested for modelling purpose.

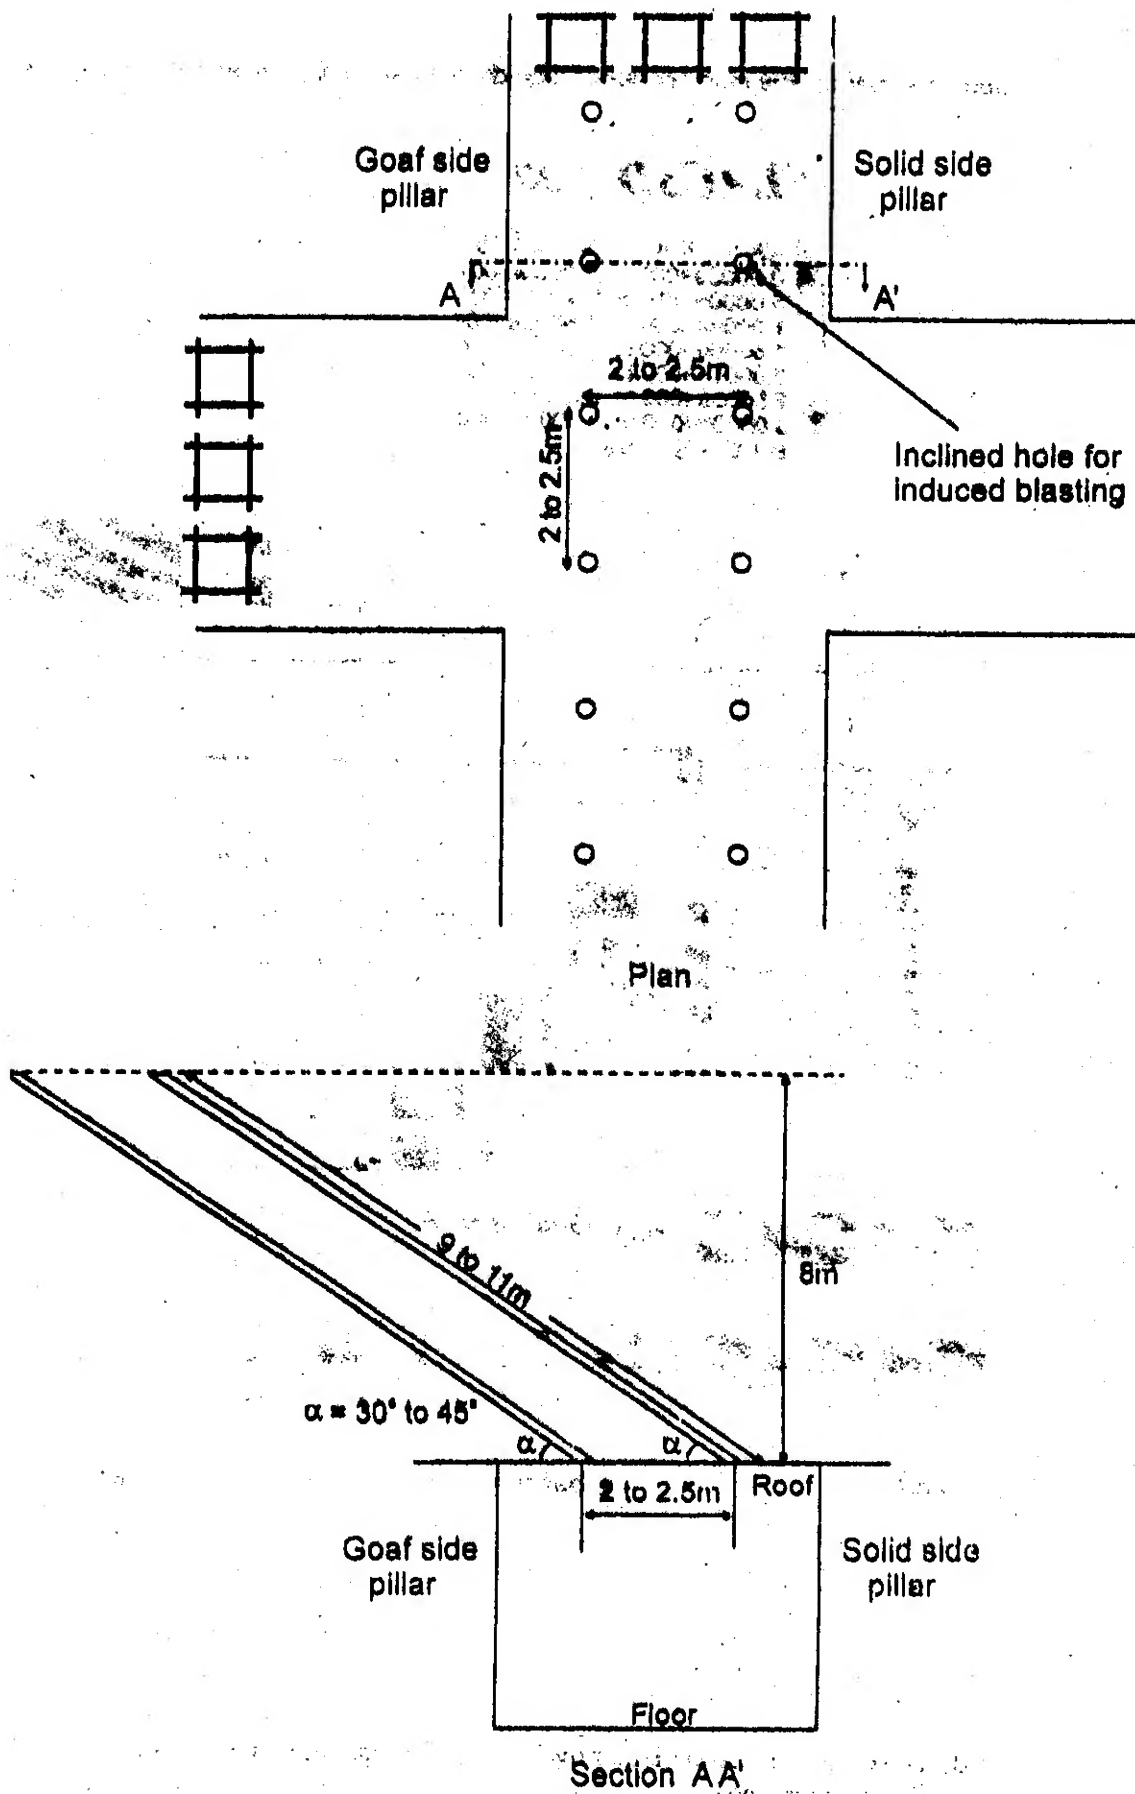
Fig. 9: Goaf edge blasting pattern for induced caving

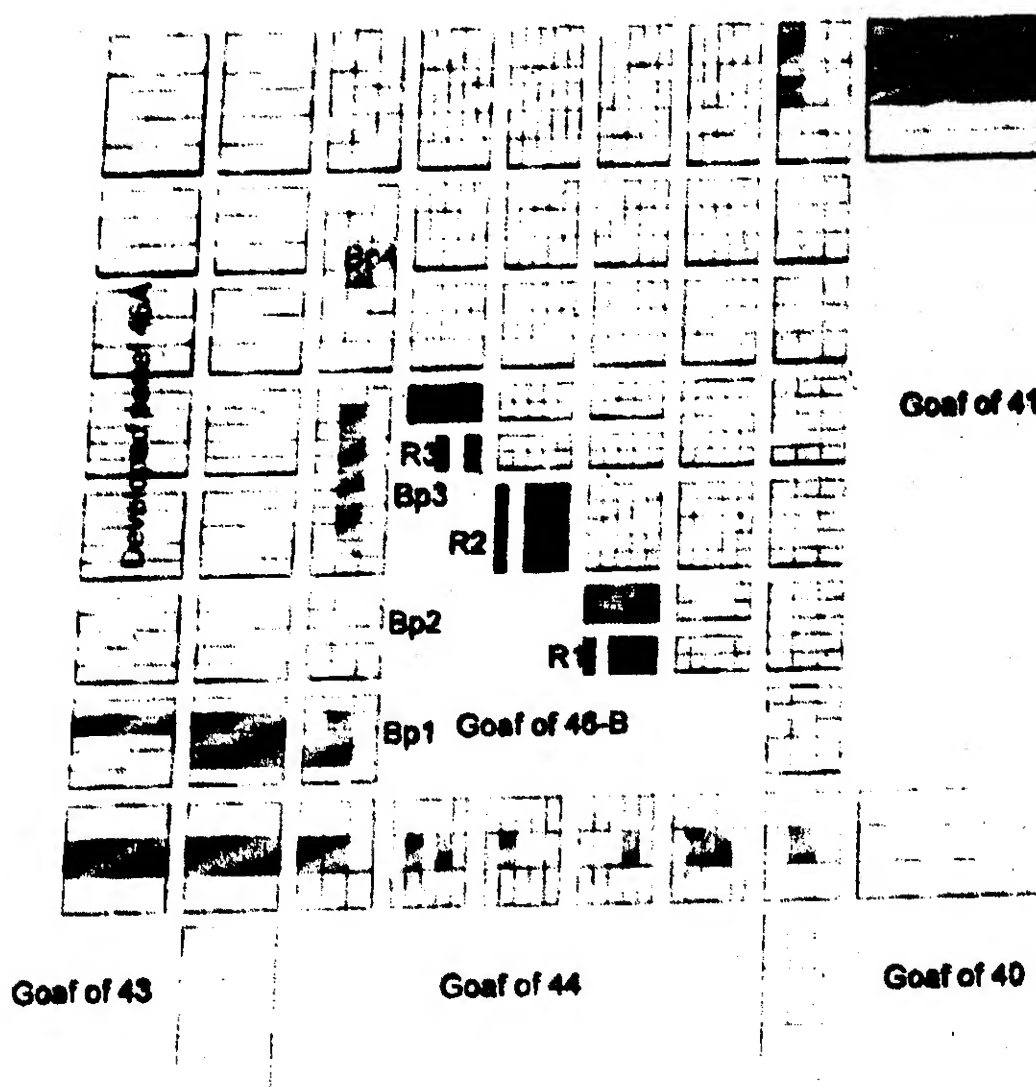
Fig7: Block contours of safety factor over different pillars of panel no 46 B with 46A panel only developed

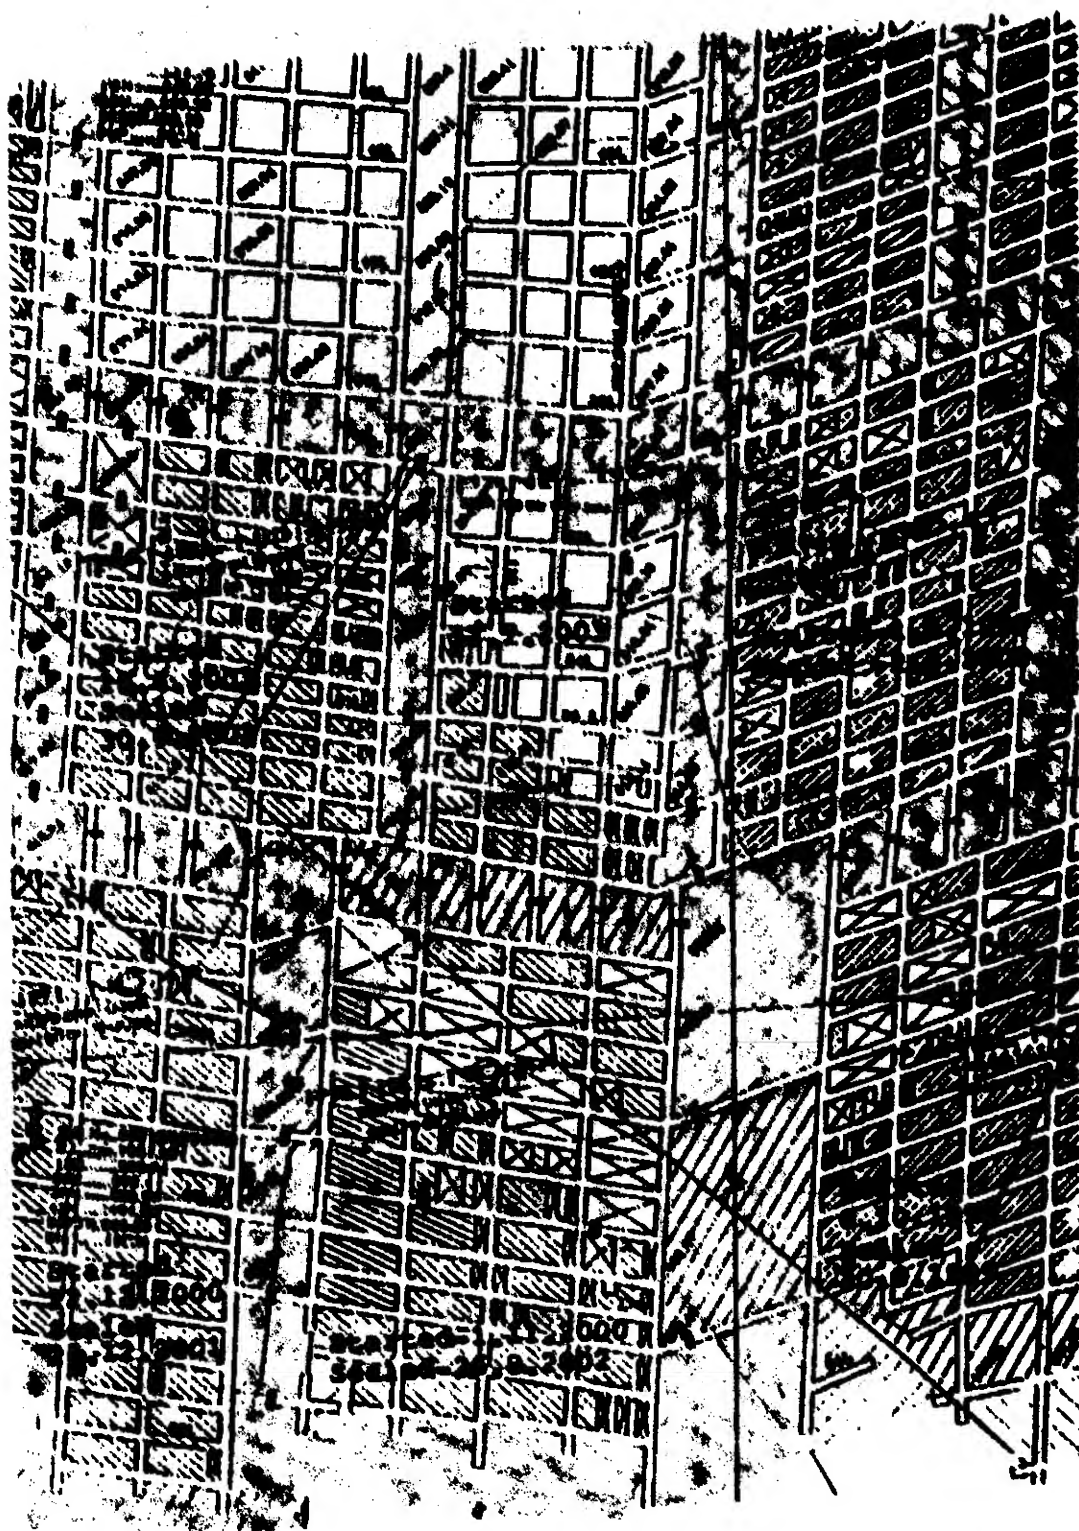
Fig.4 - Working prepositions of different panels  
at the time of accident in Panel No.653.

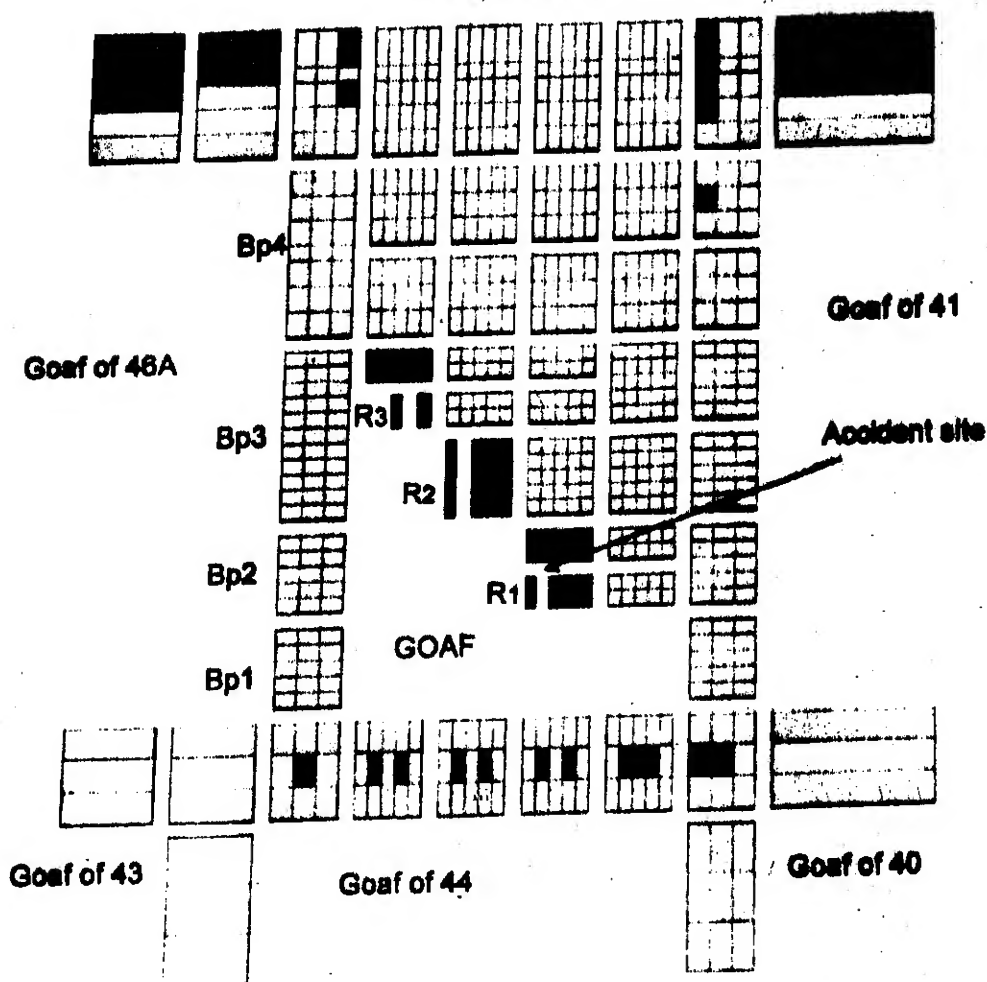
Fig. 6: Block contours of safety factor over the pillars with 3 sides of panel 46-B already extracted

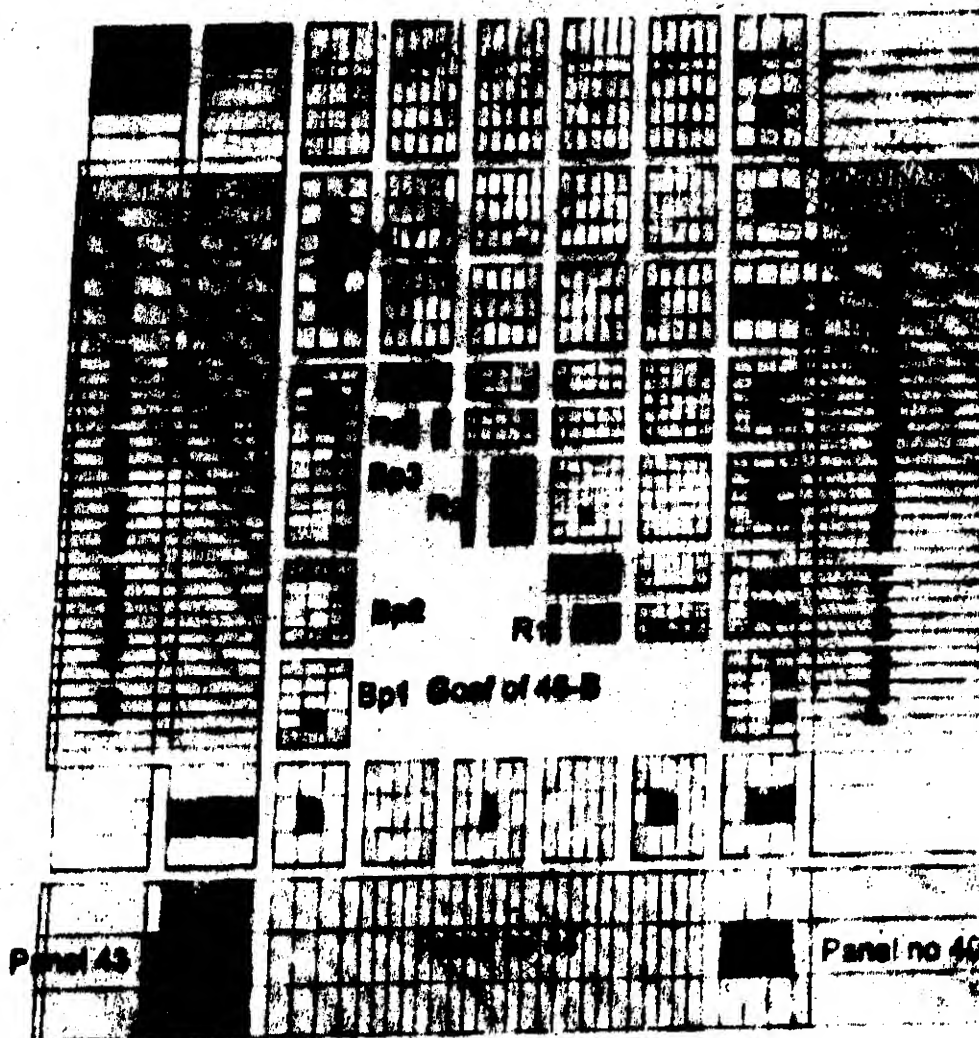
Fig.8: Block contours of safety factor over pillars with 3 sides of the panel no 46-B was extracted but goaf was completely settled

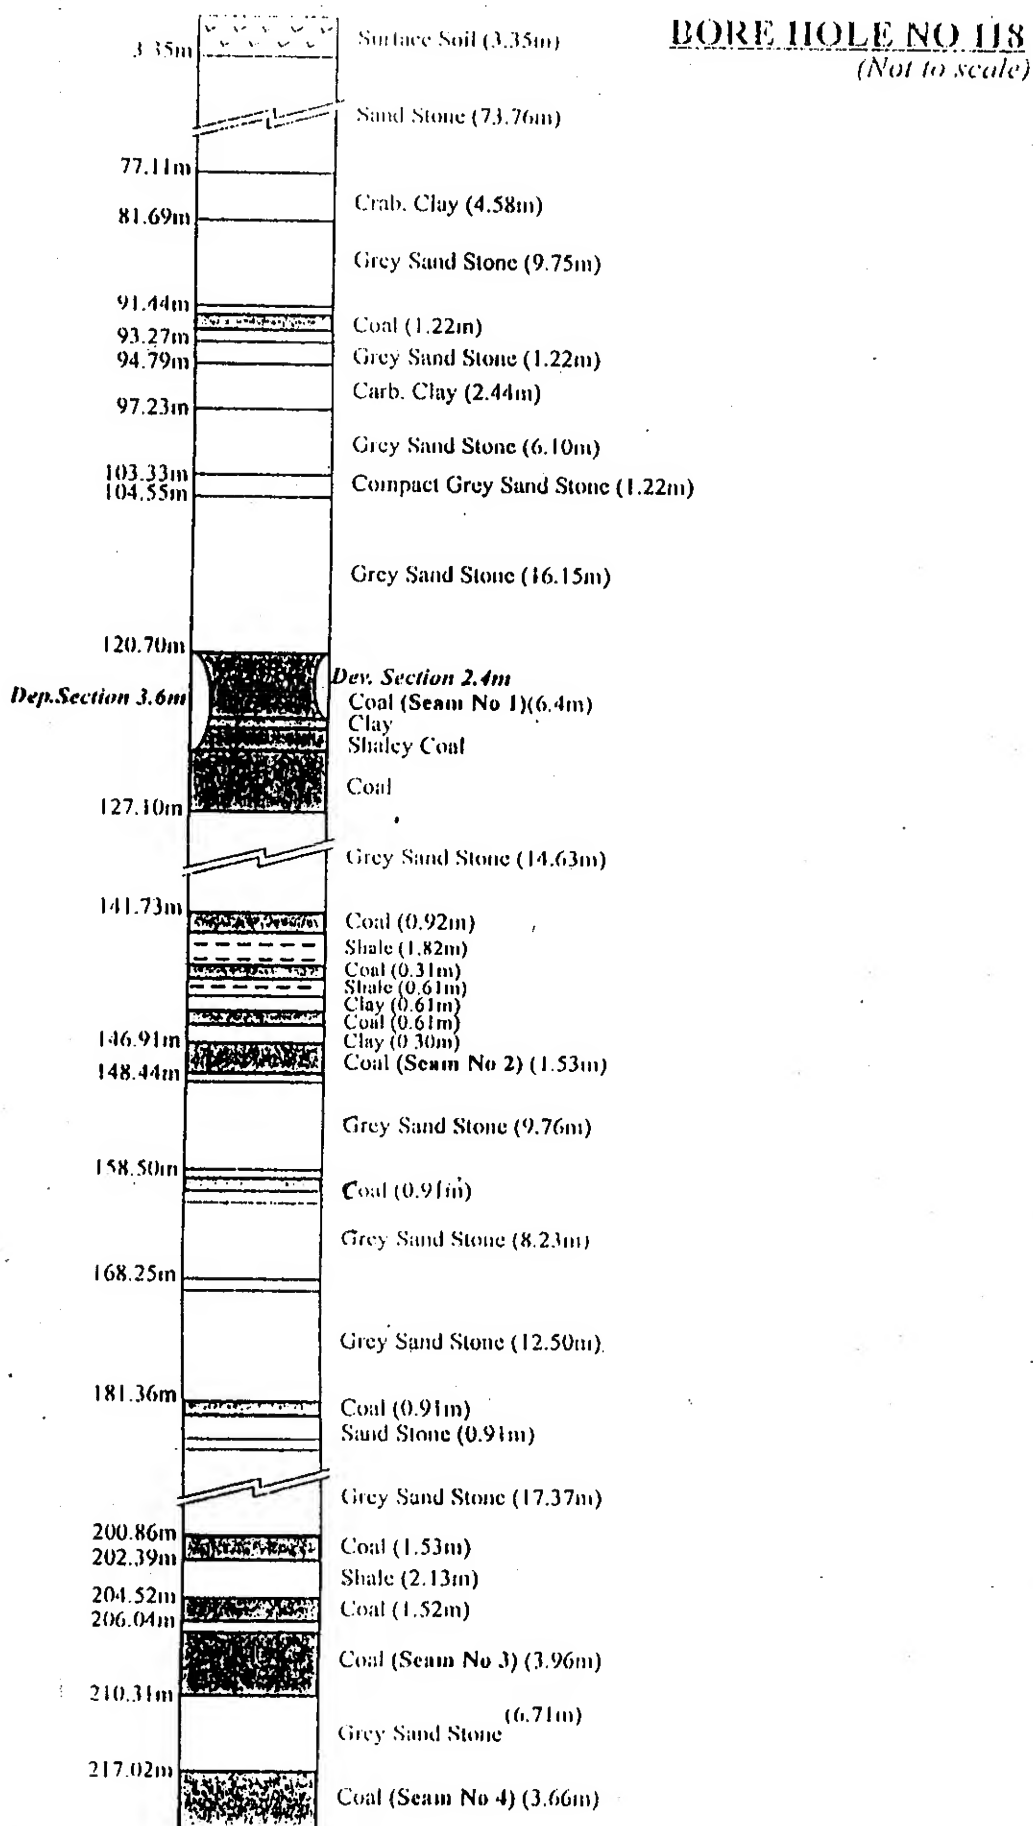
Fig 1: Section along Bore Hole No 118 showing different seams at GDK8A Incline, SCCL.

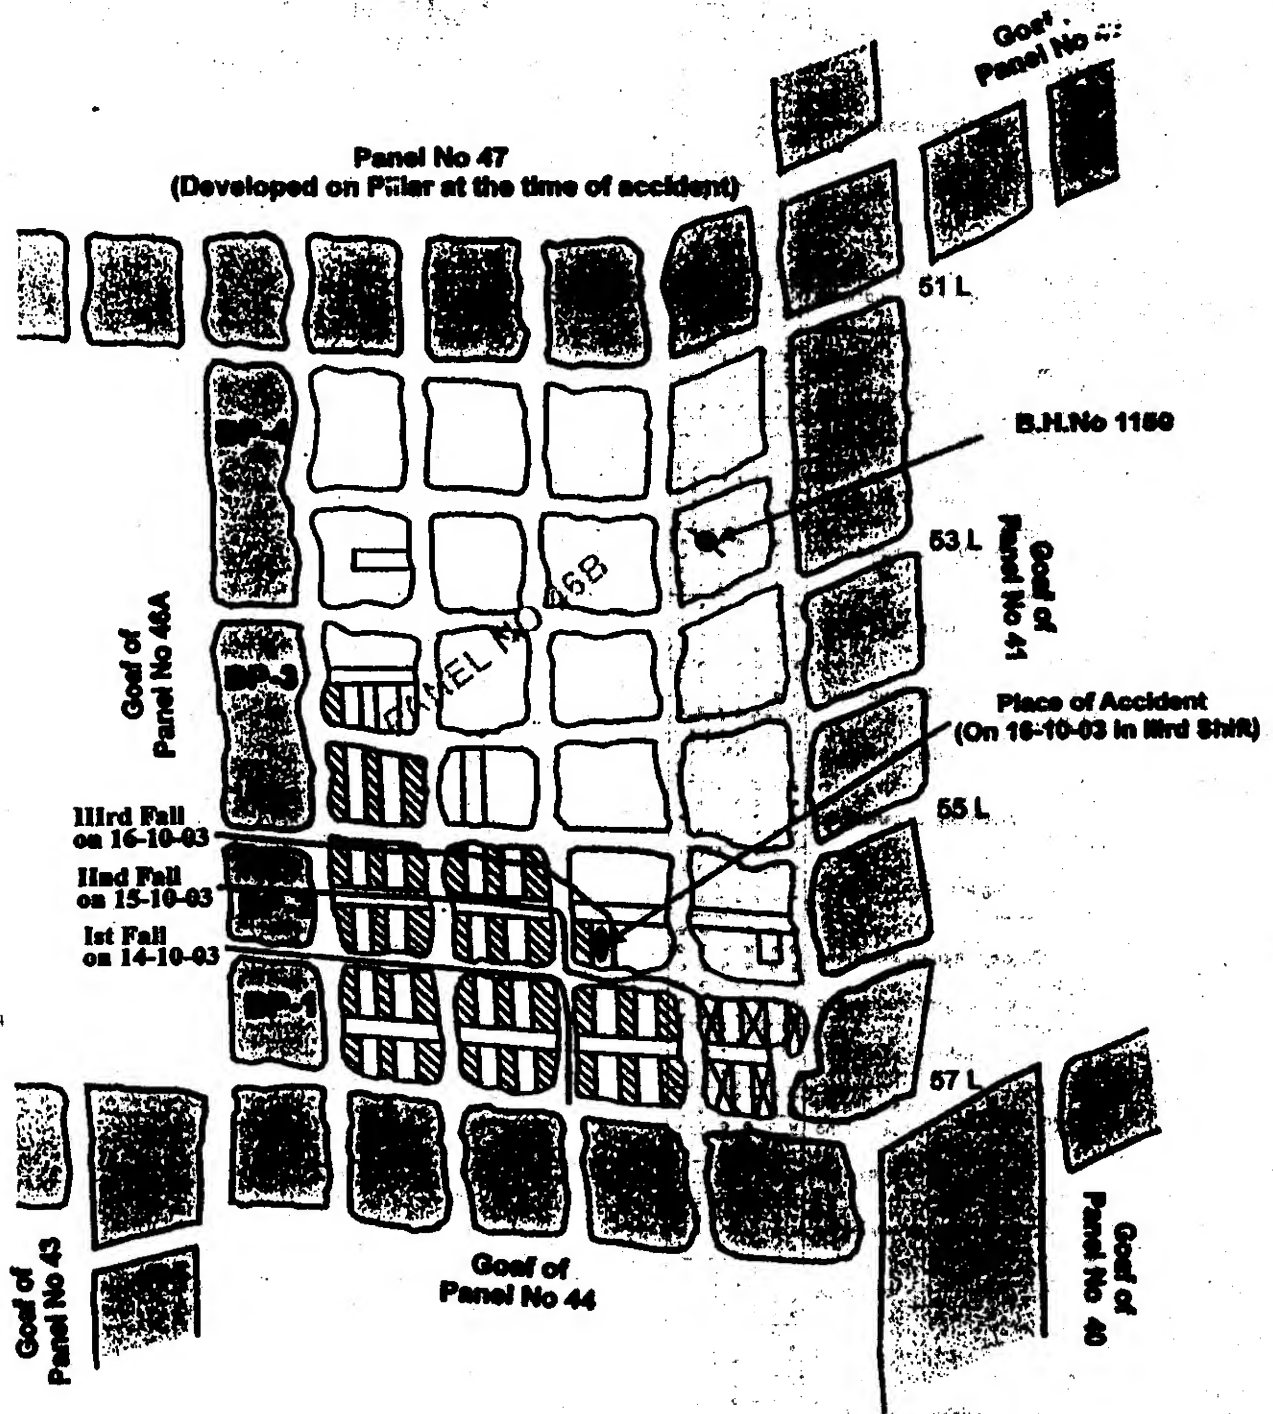
Fig 2: Part plan of the panel no 46B showing line of different falls. Bore Hole position from where rock sample were tested in CMRI laboratory for modelling.

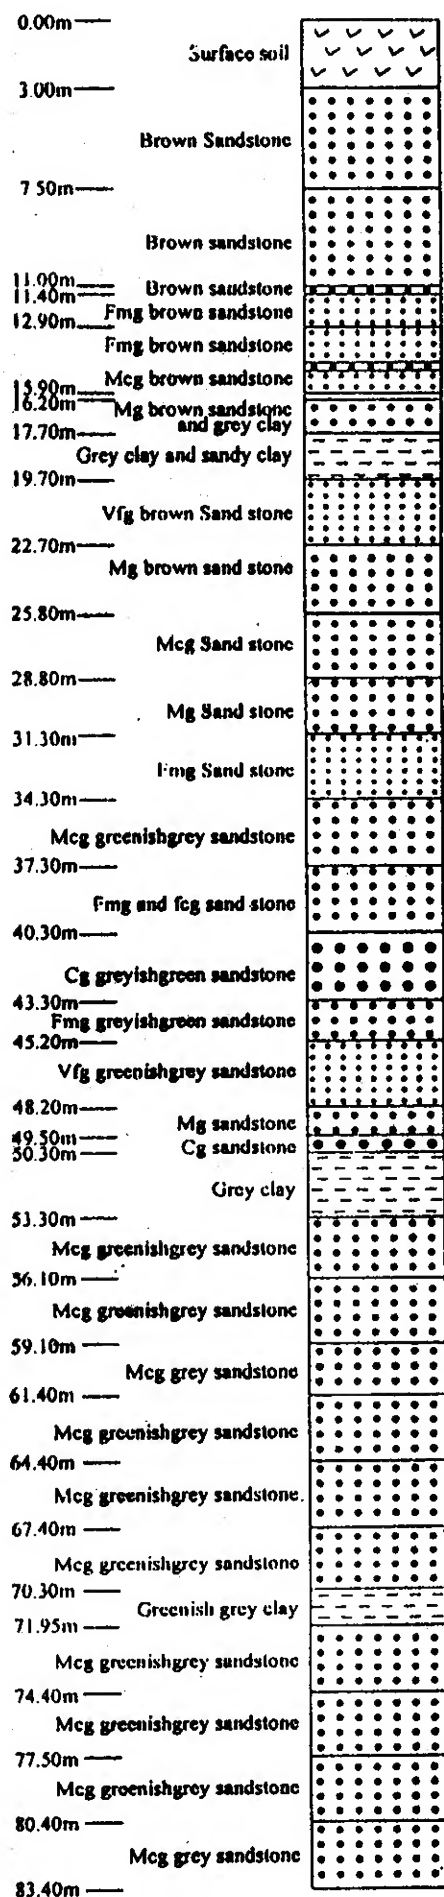
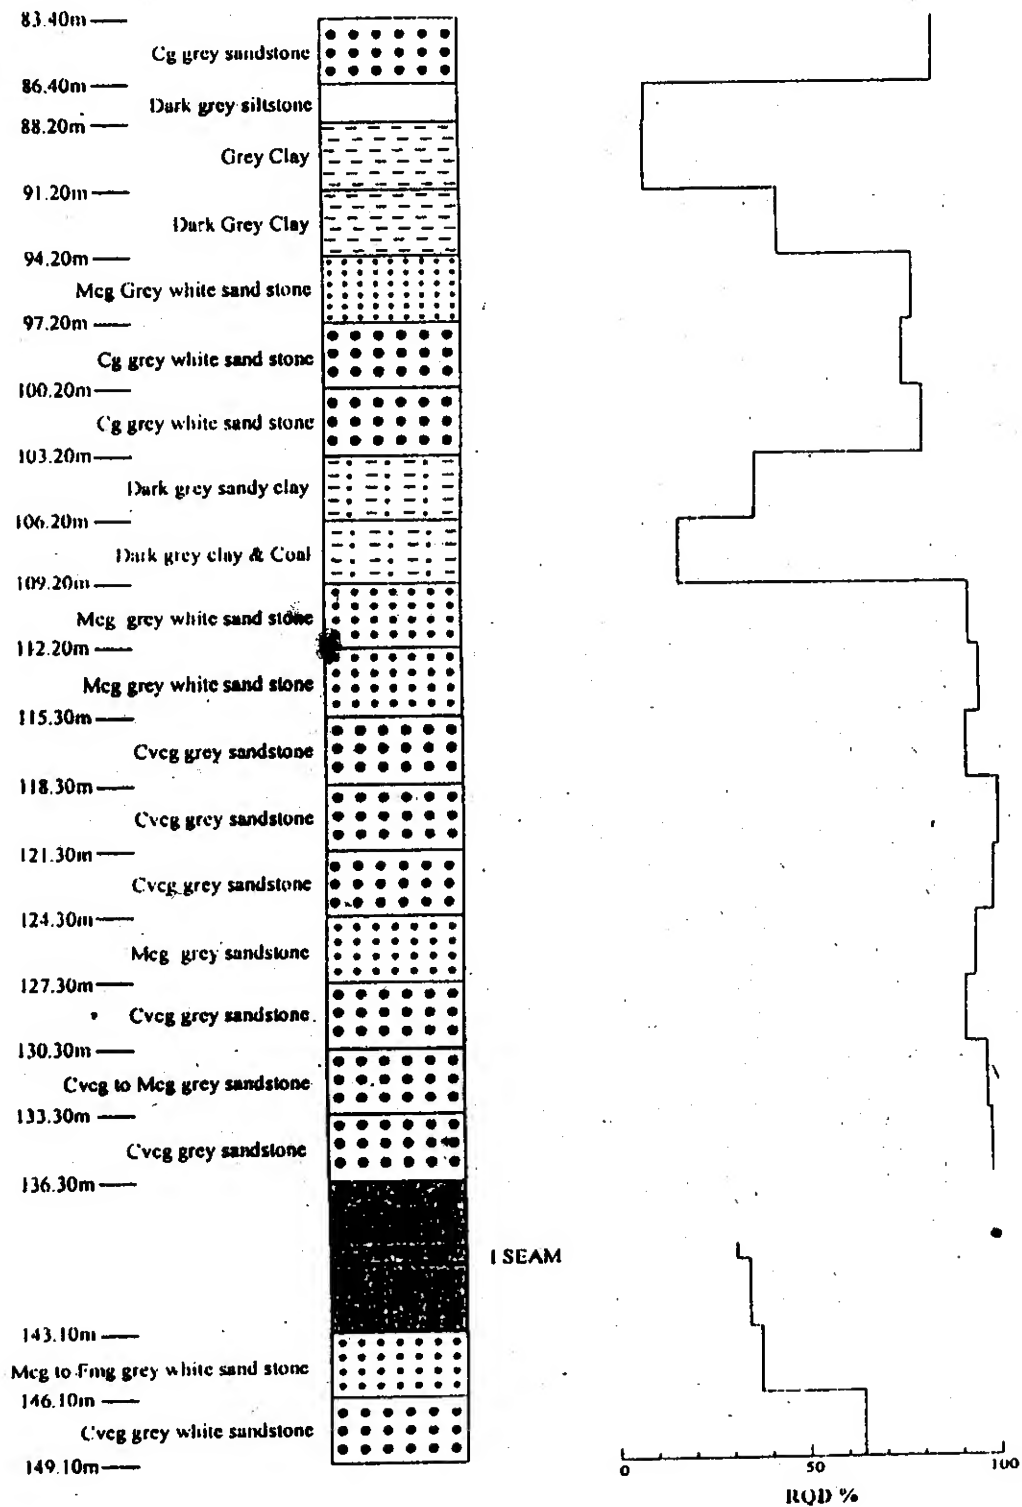
**BORE HOLE NO : 1150**  
**LOCATION : GDK-8A INCLINE**  
*(Not to scale)*

Fig 3: Section along Bore Hole No 1150, located at panel no 46B, whose rock samples were tested for modelling purpose.

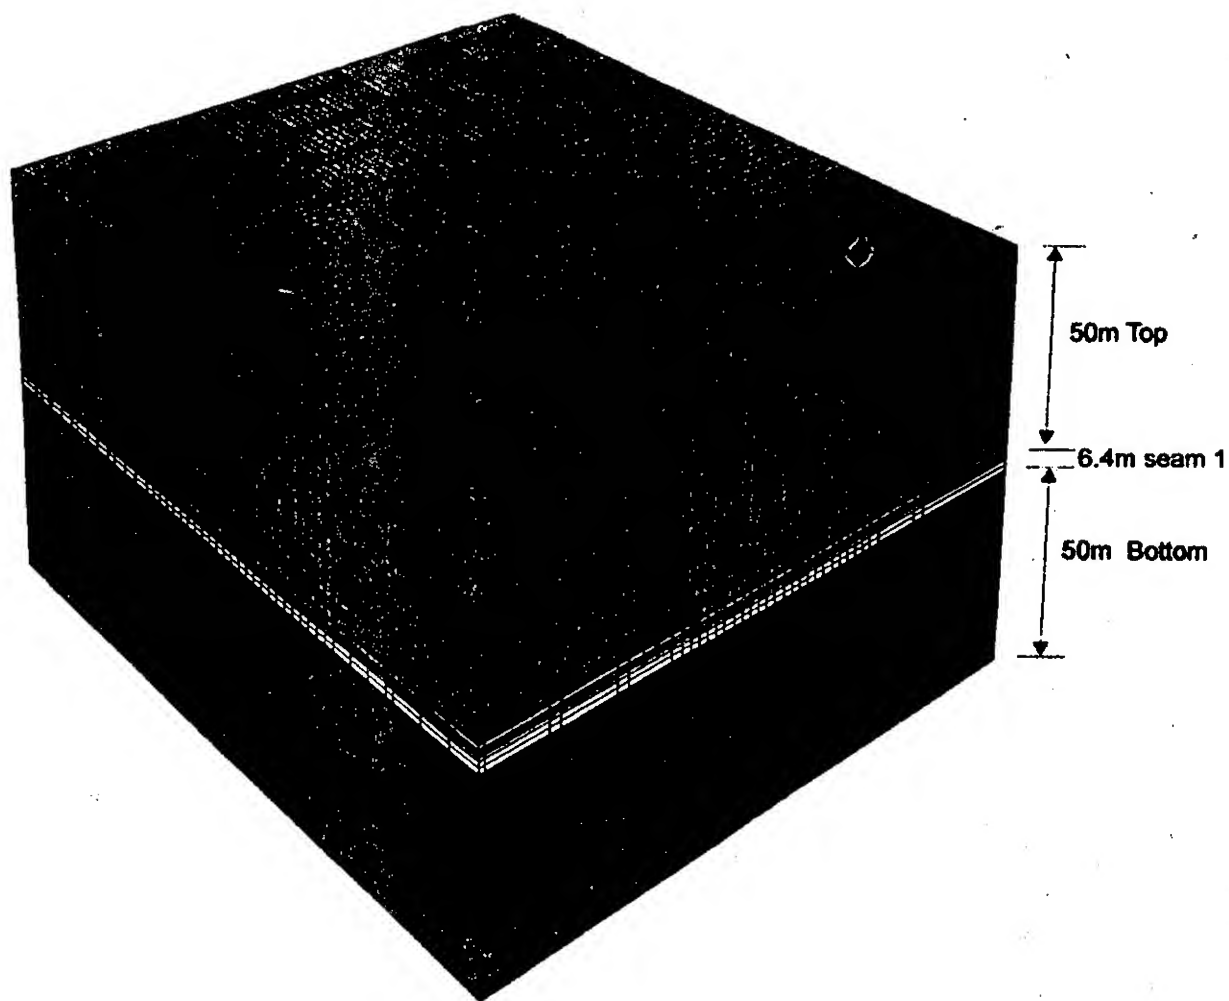
Fig.5: 3-D model showing grid pattern above and below the seam 1 at GDK 8A Incline

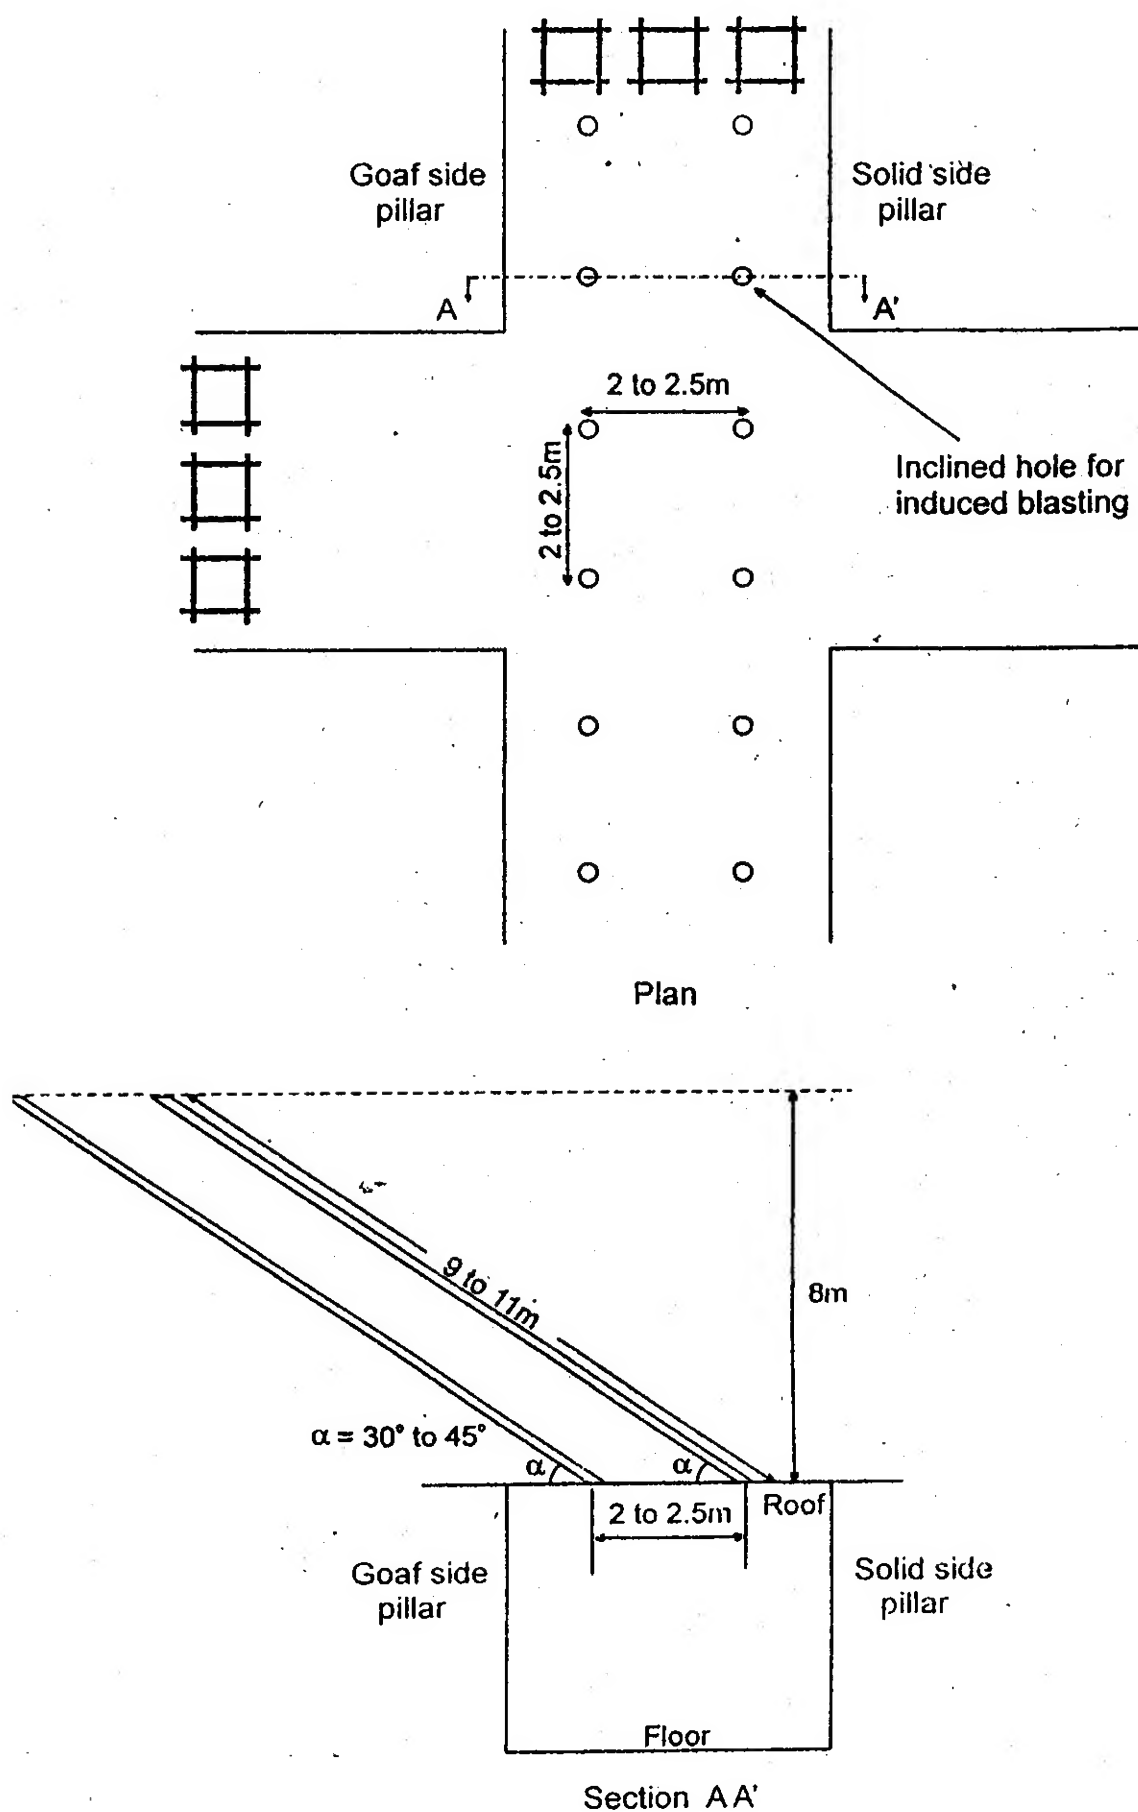
Fig. 9: Goaf edge blasting pattern for induced caving
